*Final Rehabilitation and Retrofit  
Strategy Report*

**Seventh Street Bridge Project  
Bridge No. 38C-0023**

Prepared for  
**Stanislaus County  
Department of Public Works**

June 6, 2013

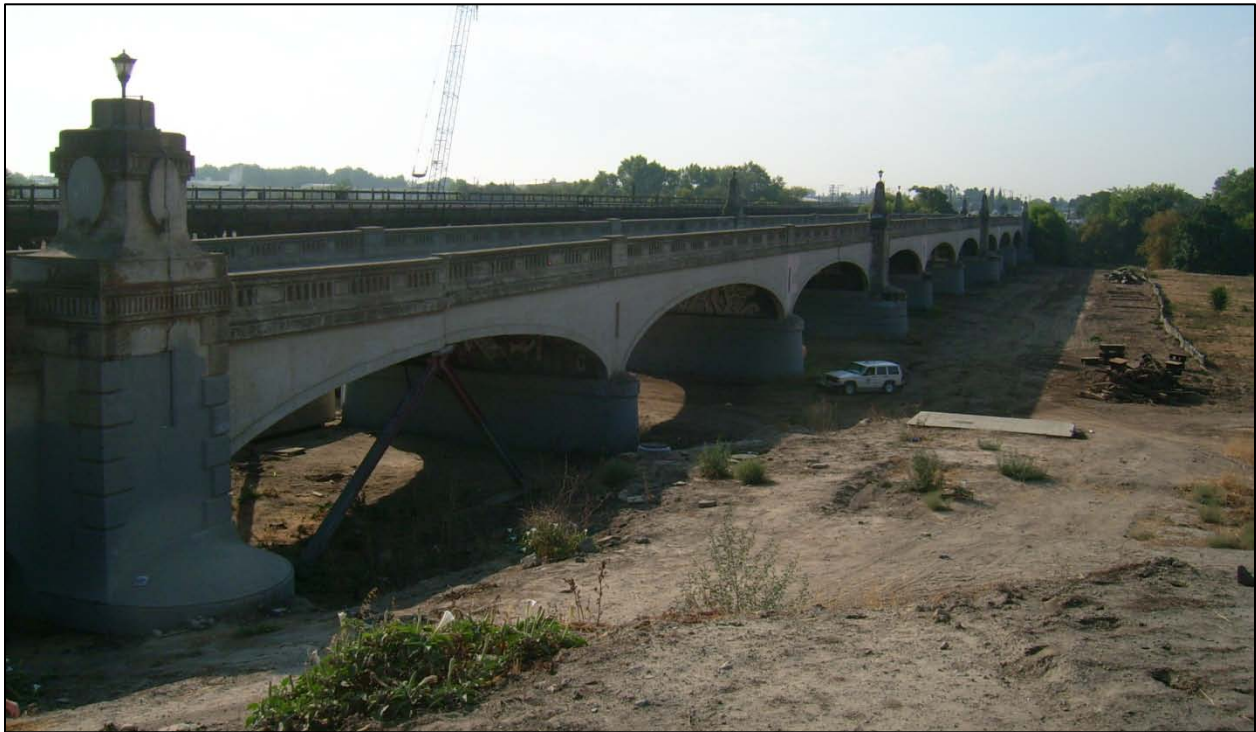
Figure 3 – West Edge of Bridge Looking South

Seventh Street Bridge was constructed in 1916 and is designated bridge number 38C-0023 (see Figure 3). The structure is approximately 34'-8" wide and 1,165-feet long, and consists of 14-spans, with two 54-foot spans, nine 84-foot spans, two 100-foot spans, and one 101-foot span. The 100-foot spans and 101-foot span are located over the low-flow Tuolumne River, while the remaining spans are above the surrounding flood plain.

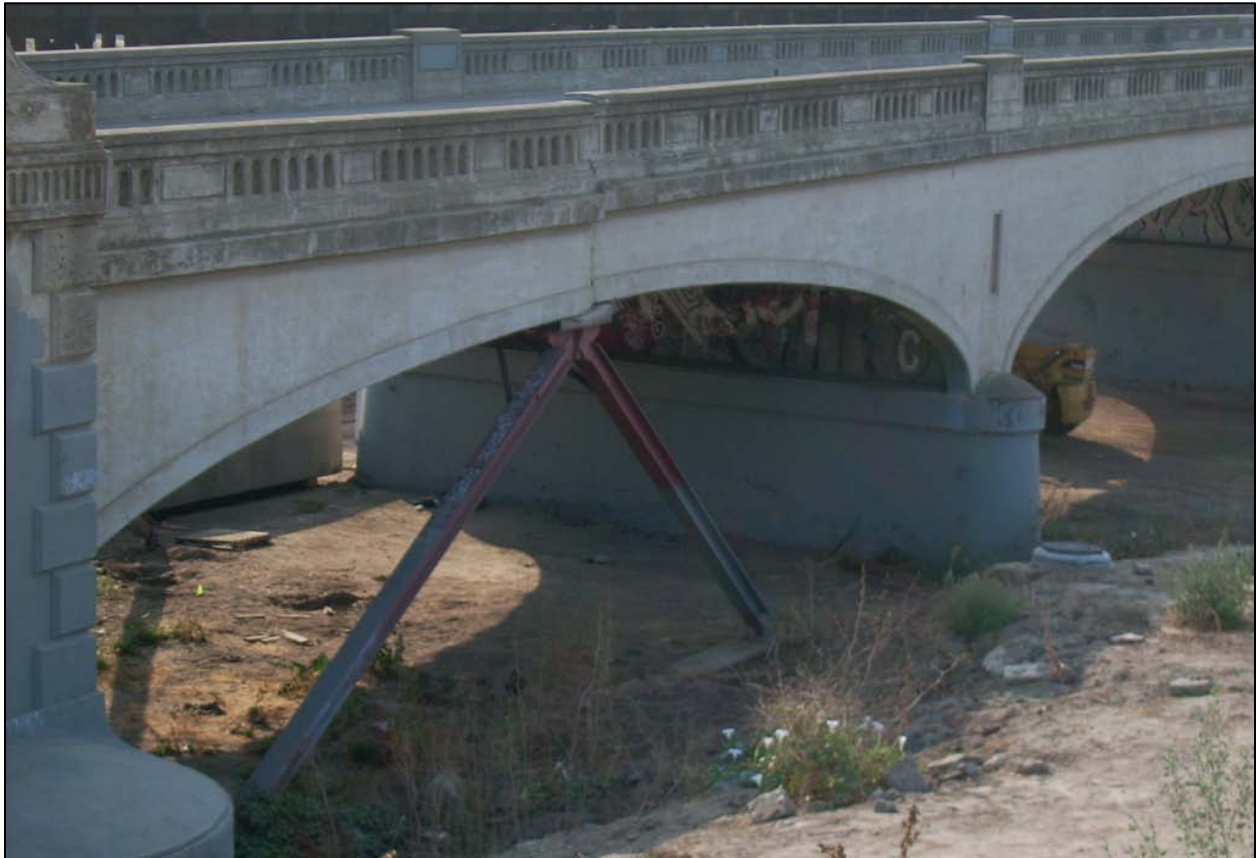
*Figure 4 - Span 13 Support at Joint*

Remedial measures were later implemented at the northern-most joint by installing a steel frame consisting of W10 x 60 sections connected by gusset plates and three-inch diameter pins and bolted to concrete footings (see Figure 4); later, shims were required due to additional differential deflection between the cantilevers. In addition, an asphalt overlay was placed to eliminate the differential displacements at the mid-span joints along the roadway surface and the bridge was posted for 4 tons. The study also

indicated that the timber piles in the river spans had been intermittently exposed based on observations by County staff.

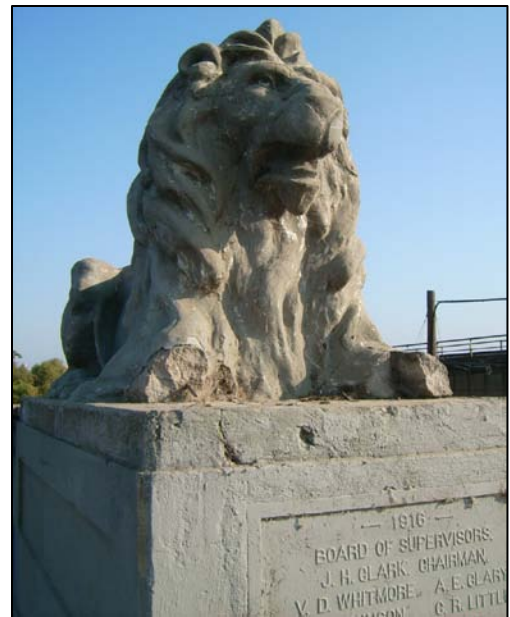
Figure 5 – Lion Statue at Bridge Entrance

The Seventh Street Bridge is the only remaining major example in the San Joaquin Valley of the "City Beautiful" bridges, adorned in "Beaux Arts" classical details, and is the most impressive surviving example of John B. Leonard's "Canticrete" bridge design. The structure exhibits a wide variety of architectural details, as shown in Figures 2 and 3. Large recumbent lions on pedestals are located at the ends of the bridge railing that artistically signify the lions are protecting the bridge (see Figure 5). Due to these statues, the bridge is often referred to by the public as the "Lion Bridge". The barrier railing has an arched window design consisting of round arched openings alternating with panels, creating strong ornamental bands. At the approaches, the railing flares outward to accommodate concrete benches. The concrete sidewalks are scored in a checkerboard pattern with a thin layer of integrally-colored concrete. The piers are treated hierarchically, with the piers closest to the approaches interpreted as the largest and most significant. The architecturally more significant piers are treated with reveals along the base of the pier and ornamental pedestals with medallion-like lighting fixtures, or electroliers, at the top of the piers above the barrier railing. Due to the historic classification and detailed architectural treatment involved with the bridge, it is important that any rehabilitation and retrofit measures preserve the architectural character of the structure.

- Architectural repairs that are necessary include patching the lion statues and benches, removing biological growth and applying a waterproof coating, cleaning and painting the bronze plaques at the bridge approaches, removing and replacing mismatched patches previously placed, and possible replacing the existing lighting fixtures with the original light fixtures detailed on the as-built plans. Note that the concrete used to patch the existing spalls should be designed to match the color and texture of the existing concrete.

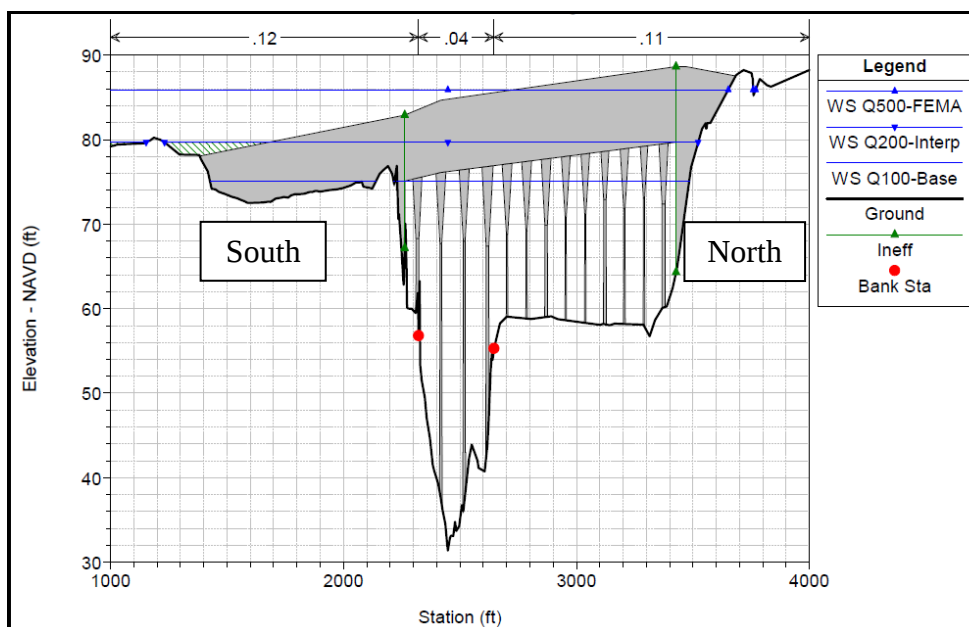
Figure 8. Cross-Sectional View of the Existing 7<sup>th</sup> Street Bridge, Looking Downstream

The north abutment of the existing bridge has approximately 4.5 ft of freeboard during the design 100-year storm event, but the south abutment would not have freeboard (see Table 6). The existing 7<sup>th</sup> Street bridge would not be overtopped during the design 200-year storm event, but the approach area south of the bridge would be overtopped (see Figure 8). During the design 500-year storm event, the southern portion of the existing 7<sup>th</sup> Street bridge would be overtopped (see Figure 8).
