*Final Rehabilitation and Retrofit  
Strategy Report*

**Seventh Street Bridge Project  
Bridge No. 38C-0023**

Prepared for  
**Stanislaus County  
Department of Public Works**

June 6, 2013

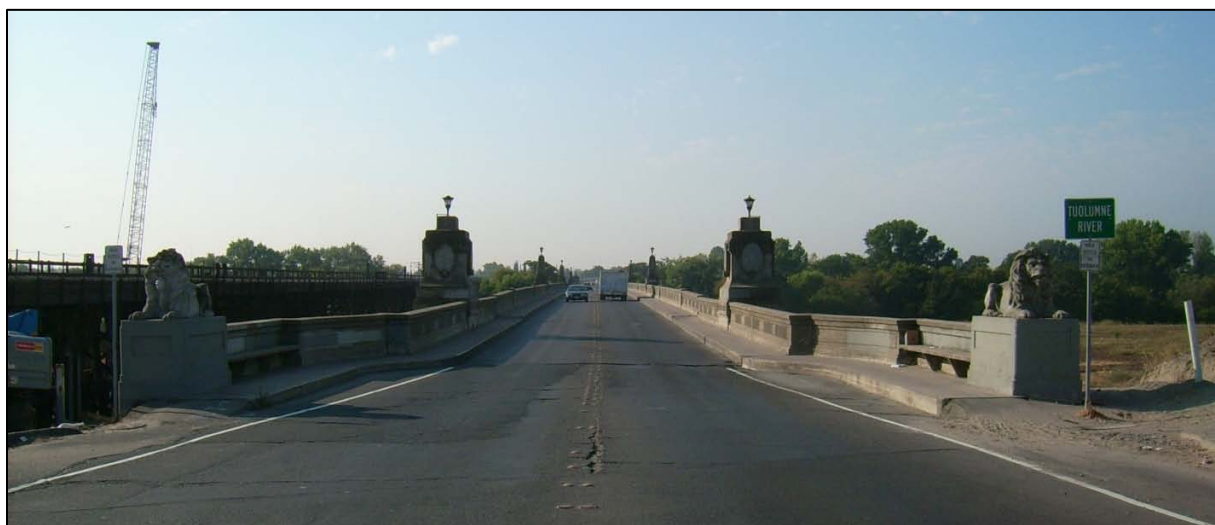
Figure 2 - Seventh Street along Bridge

The roadway alignment in the vicinity of the bridge follows a reverse curve with the bridge located along a tangent between the two curves (see Figures 1 and 2). Along the tangent portion of the alignment, the cross section is crowned at the centerline of the roadway with cross slopes for drainage. The roadway profile consists of a crest type vertical curve with a maximum elevation change along the bridge profile of approximately two-feet. Seventh Street provides two 12-foot wide lanes, one lane for each direction of traffic, with no appreciable shoulders. The roadway asphalt is generally cracked and abraded with multiple potholes located along the bridge approaches and deck overlay. According to the Caltrans inspection report, the approach roadway alignment has an appraisal rating of 6 (satisfactory condition), though the approach railing is substandard.

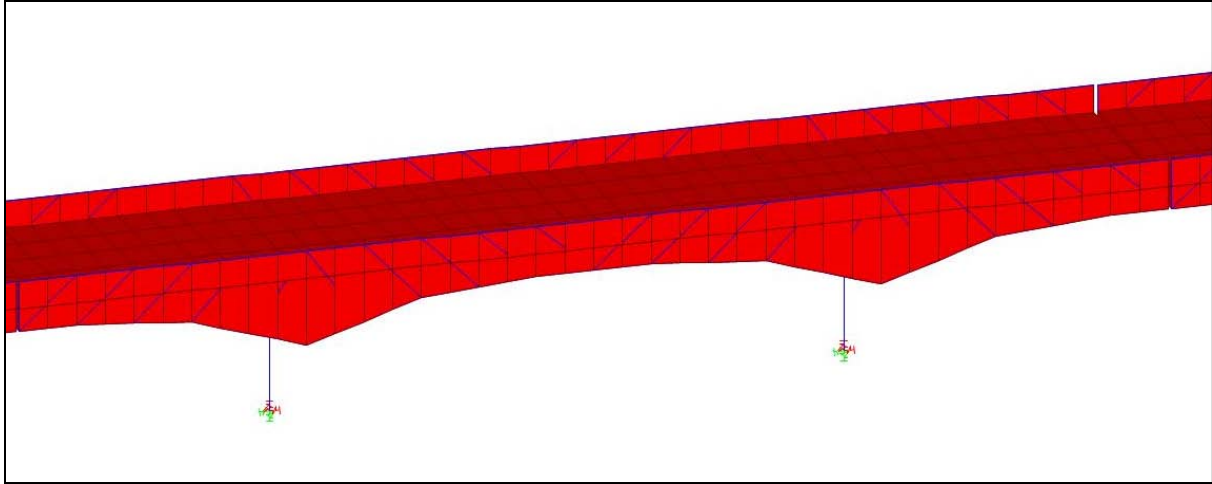
Figure 6 – Single Frame from CSI Bridge Model

Screenshots from the CSI Bridge model that shows a single frame of the bridge between mid-span joints is provided in Figures 6 and 7 below. In Figure 6, the blue lines represent the steel truss members and the red shell elements represent the concrete arches and deck. A small gap can be seen at each end of the figure that represents the mid-span joints at the end of the cantilevers. In Figure 7, only the frame elements that represent the steel truss members and piers are shown.
