7th Street Bridge Project

Public Scoping Meeting October 14, 2013

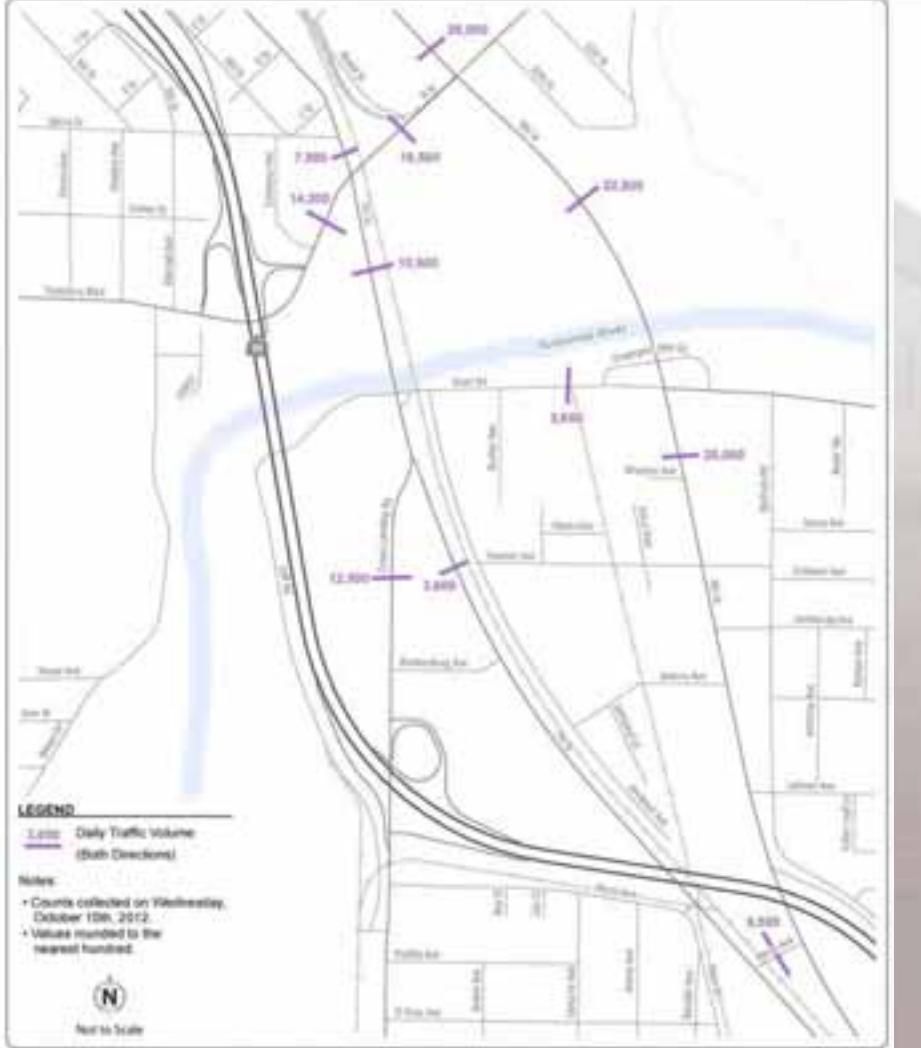
Existing Average Daily Traffic (ADT) volumes in study area

<1% trucks on 7th Street Bridge

7% trucks on 9th Street Bridge

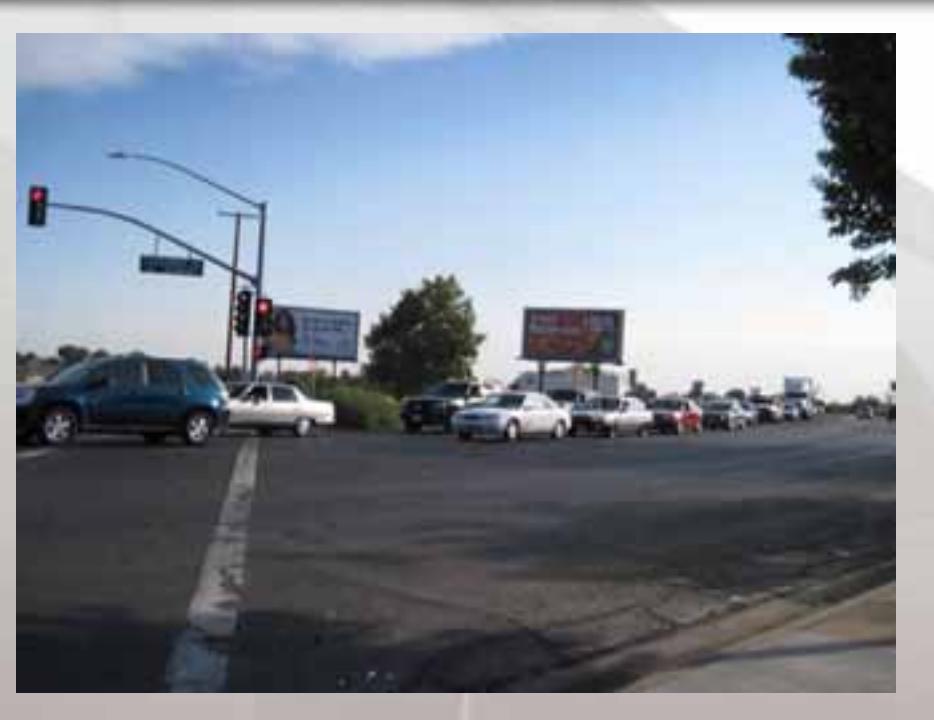
Eastbound traffic on Tuolumne Blvd

Intersection currently operates at Level of Service (LOS) D

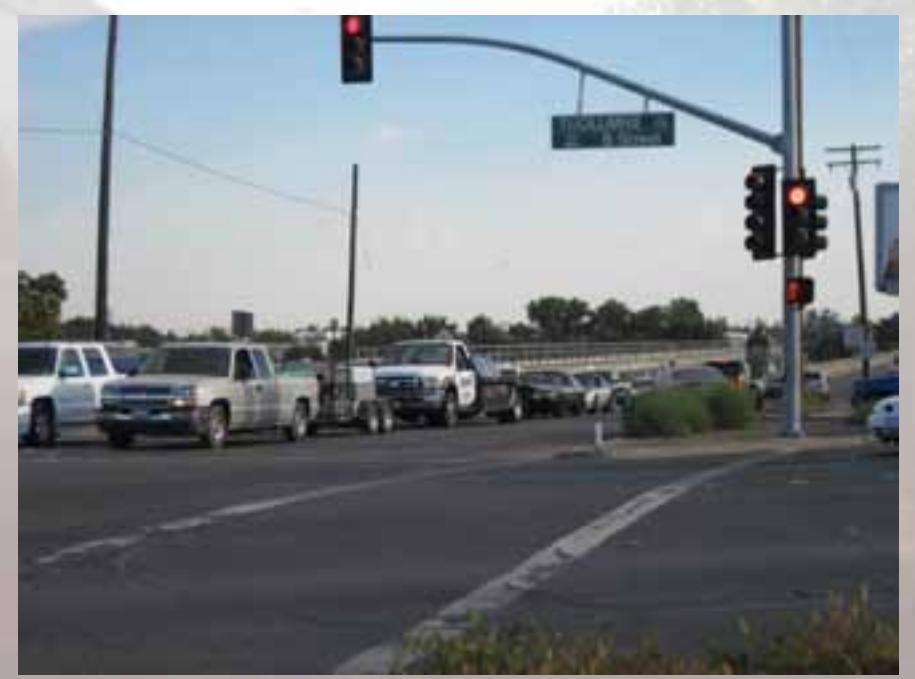
Northbound traffic on 7th Street

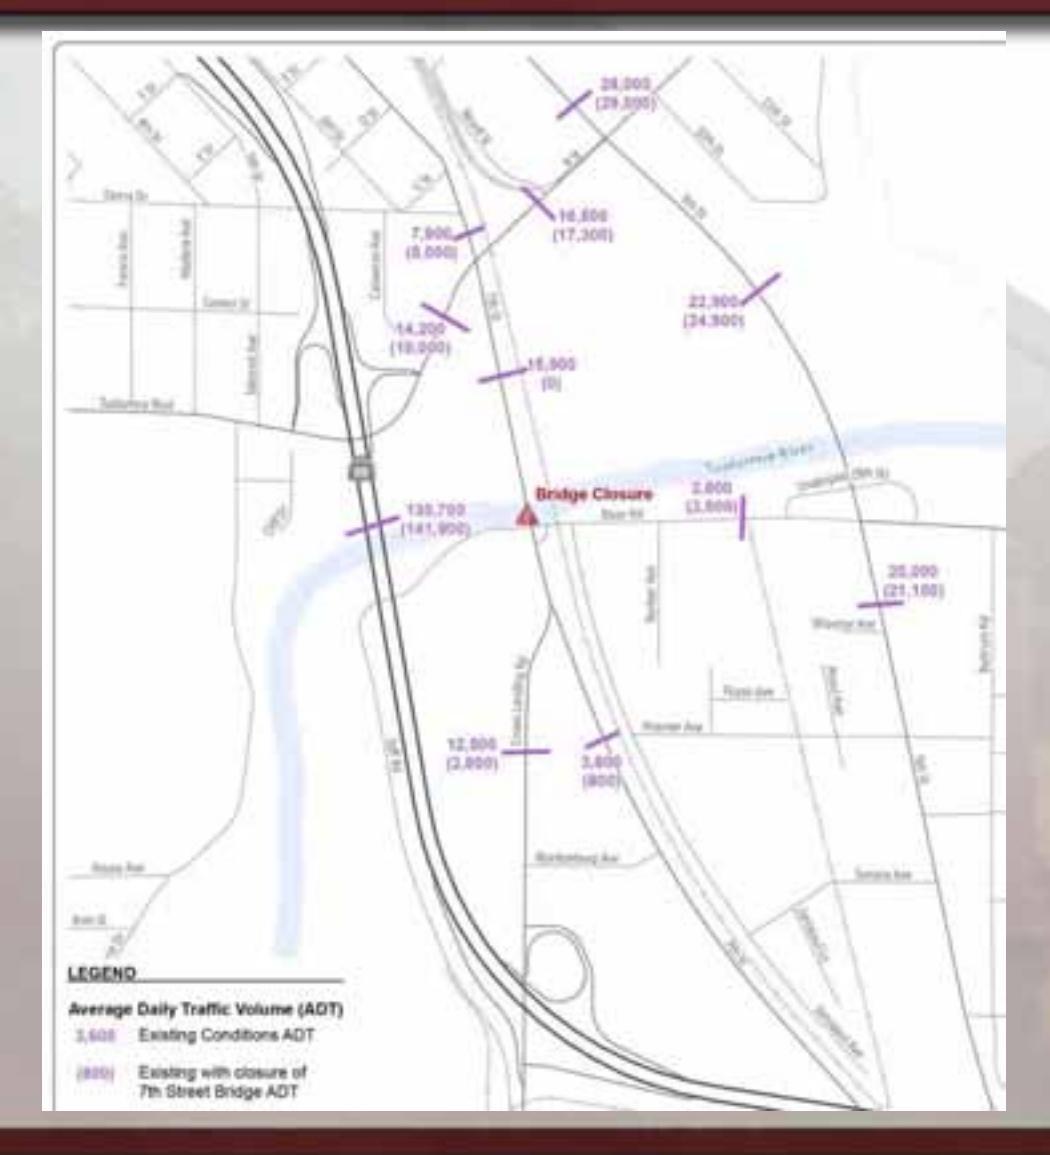
Effect of 7th Street Bridge Closure Under Existing Conditions

•Majority of Traffic Would Divert to Highway 99

Highway 99 Operations Across
 River Would Worsen During PM
 Peak Hour:
 ▶NB: LOS C to D

SB: LOS D to E
